SLOPE STABILITY ANALYSIS OF OPEN CAST MANGANESE ORE MINE-DONGRI BUZURG MOIL

B.Tech & M.Tech Dual Degree

MINING ENGINEERING

DEPARTMENT OF MINING ENGINEERING
NATIONAL INSTITUTE OF TECHNOLOGY
ROURKELA-769008
2010 - 2015

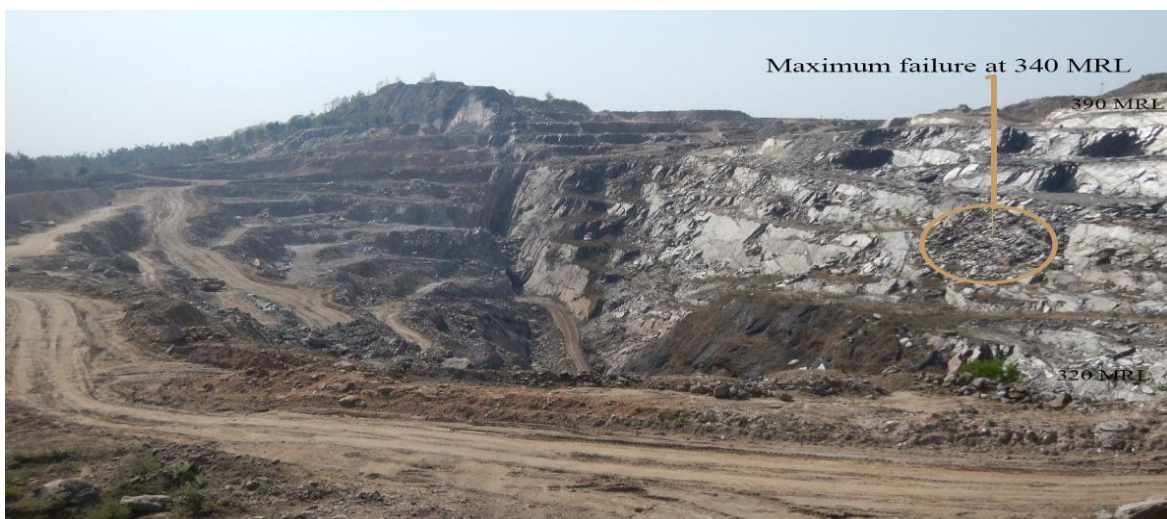
Fig.3.1: Overview of the Dongri Buzurg Mine, MOIL

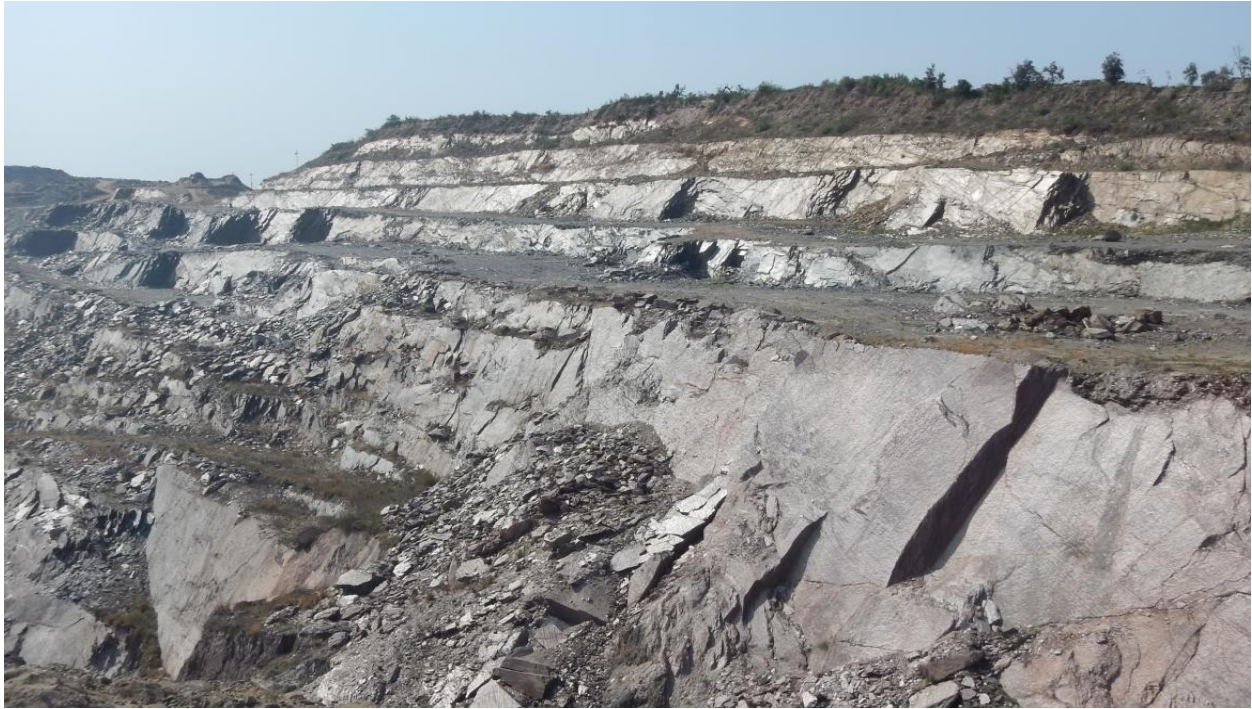
Fig.3.2: Footwall of the Dongri Buzurg Mine, MOIL

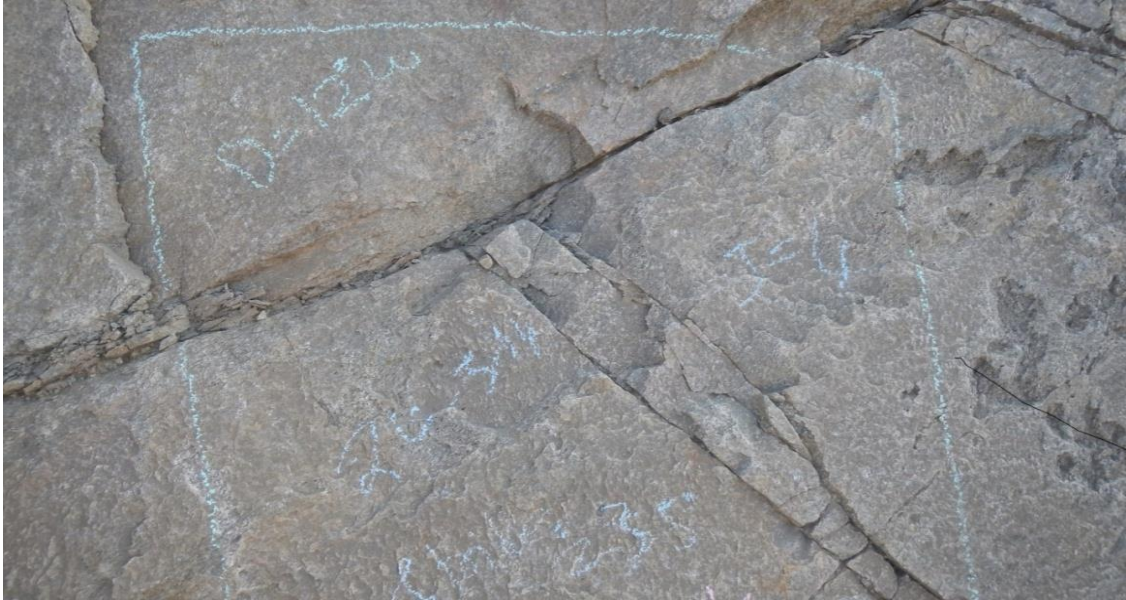
Fig.4.2 (b): Joint survey images: Bench-7, footwall Joints=4, dip=12⁰, strike=235⁰

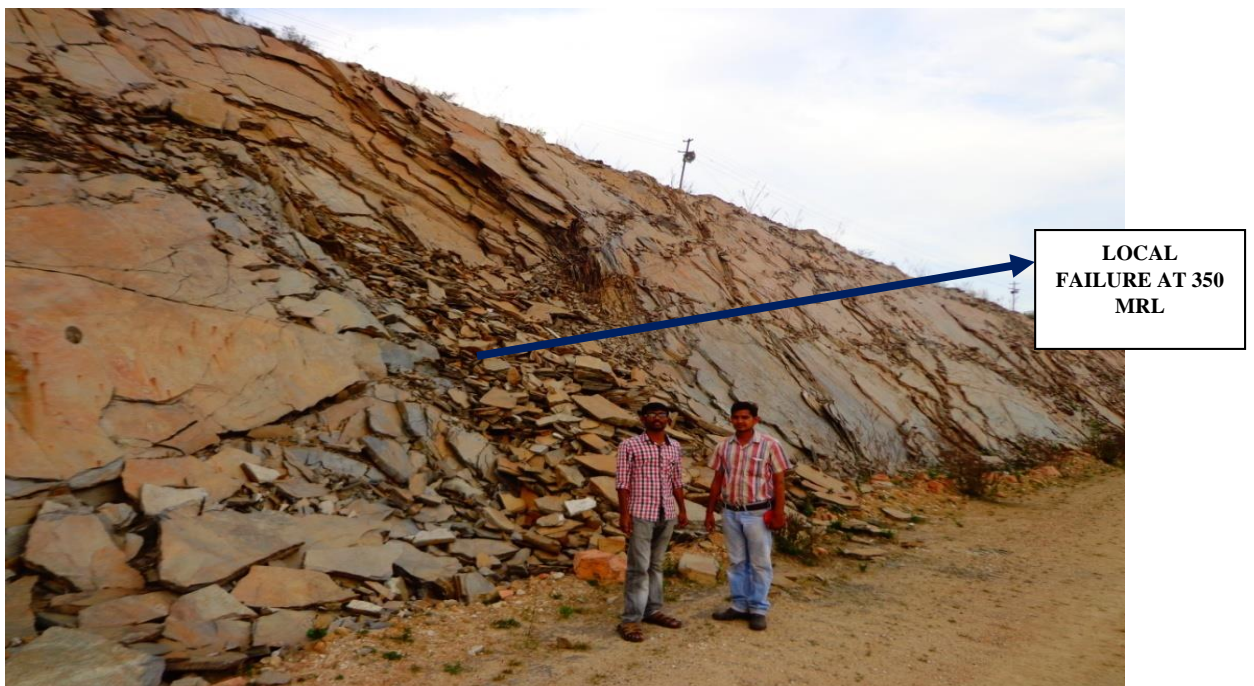
Fig.4.2 (c): Local failure at 350 MRL at footwall bench.

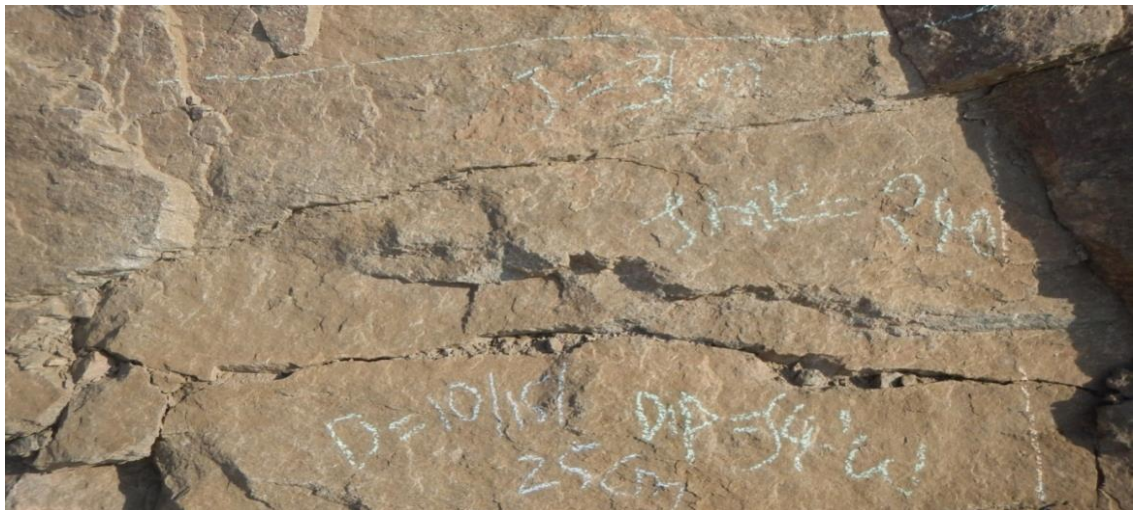
Fig.4.3 (a): Joint survey images: bench-7 hangwall Joints=3, dip=4⁰, strike=240⁰

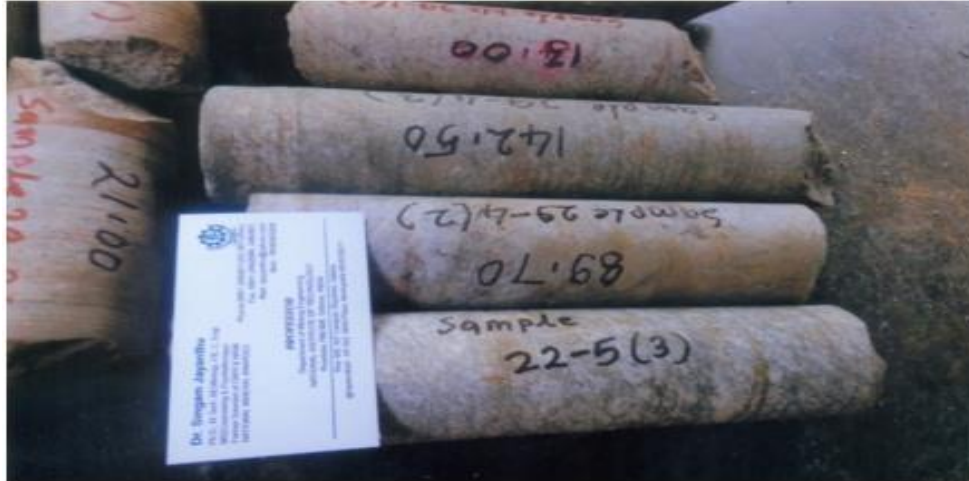
Fig.5 (a): Bore hole samples of Dongri Buzurg Mine

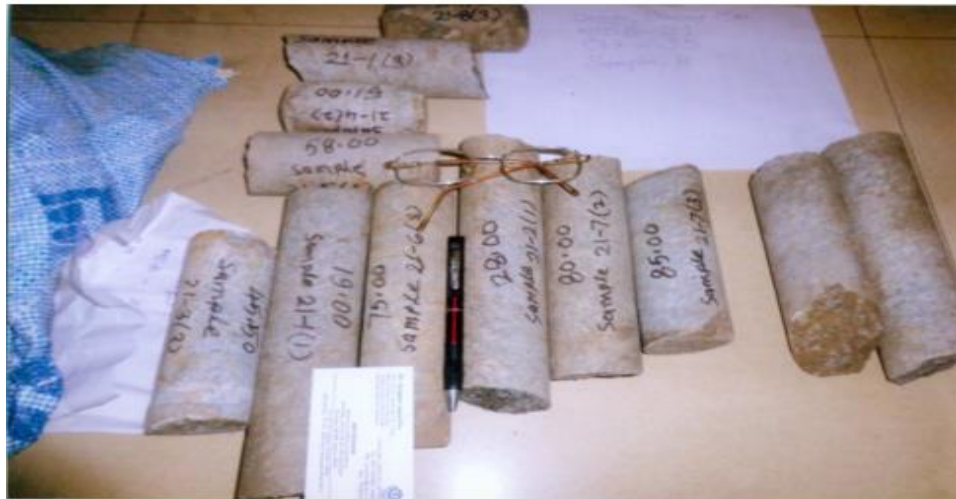
Fig.5 (b): Bore hole samples of Dongri Buzurg Mine

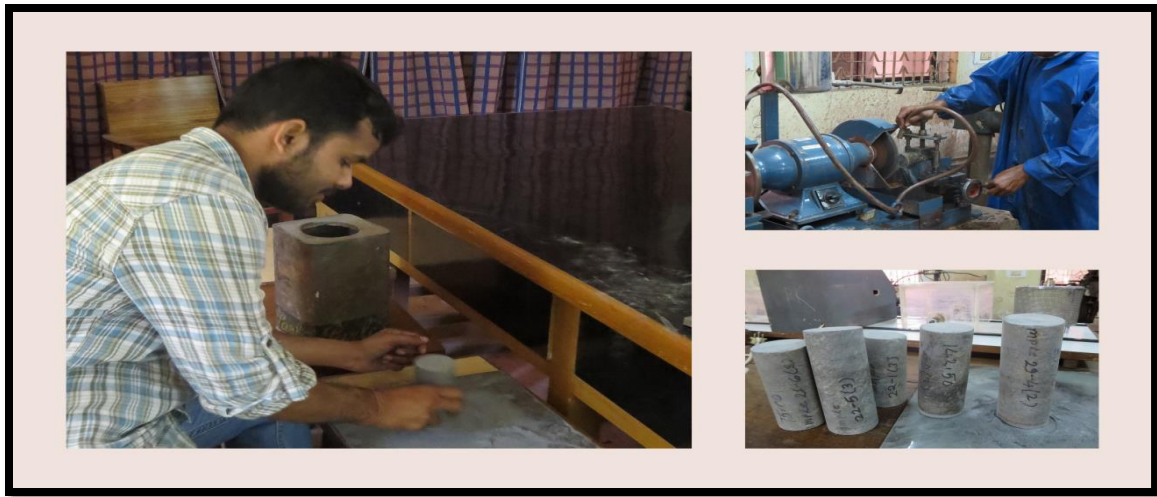
Fig.5.1.1: Sample Preparation

rock samples were determined in Triaxial testing. Different phases of sample preparation are shown in fig. 5.1.1.

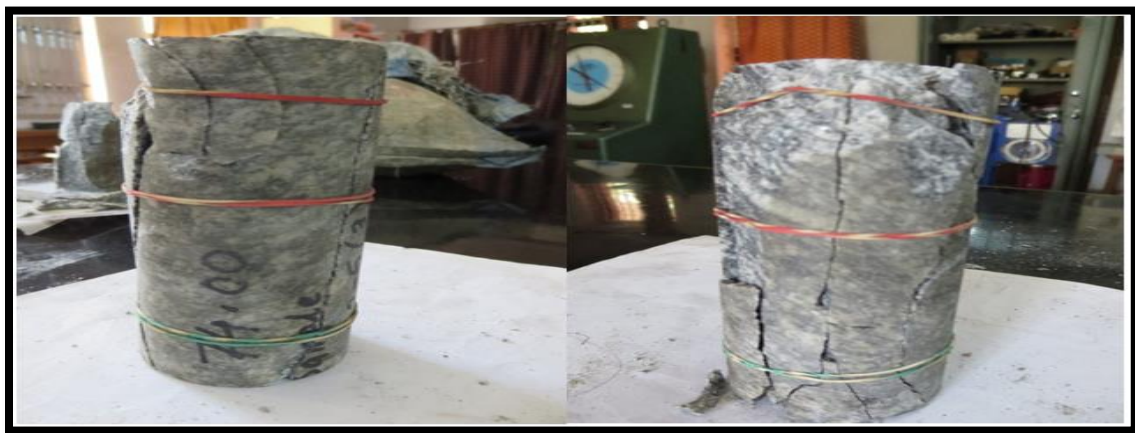
Fig.5.1.1 (a). Fracture profile of Quartz Muscovite Schist after completion of UCS test.

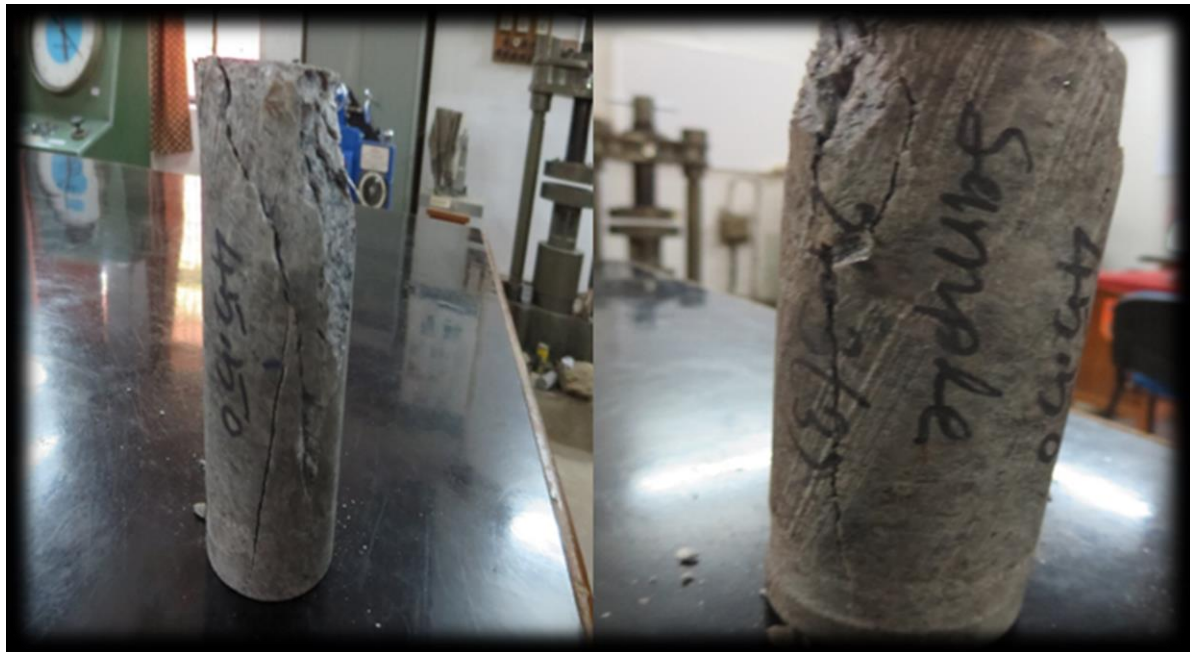
Fig.5.1.1 (b). Fracture profile of Tirodi Biotite Gneiss after completion of UCS test.

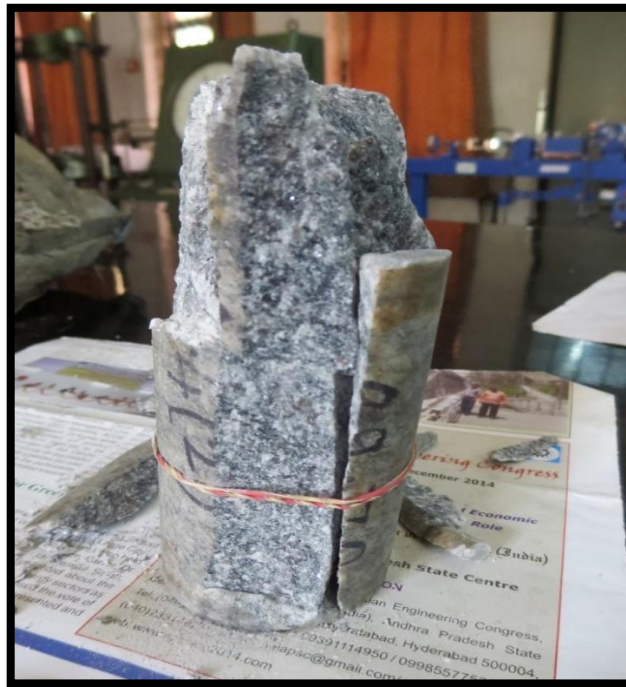
Fig.5.1.1(c): Fracture profile of Quartz Mica Schist after UCS test.

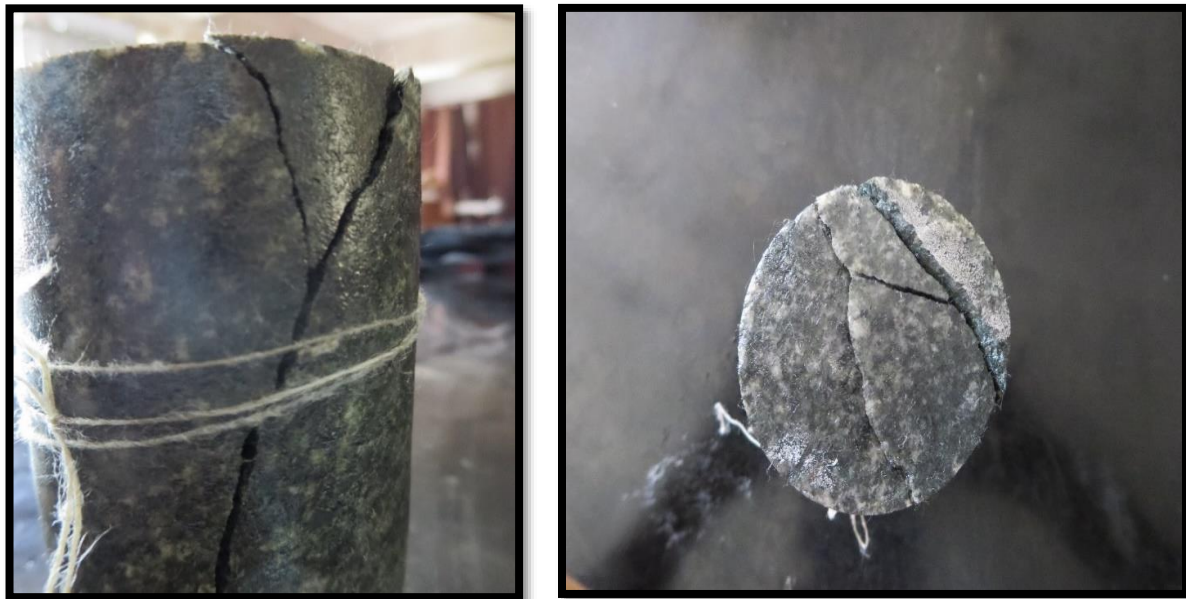
Fig.5.1.2 (a). Fracture profile of Tirodi Biotite Gneiss after Triaxial test.

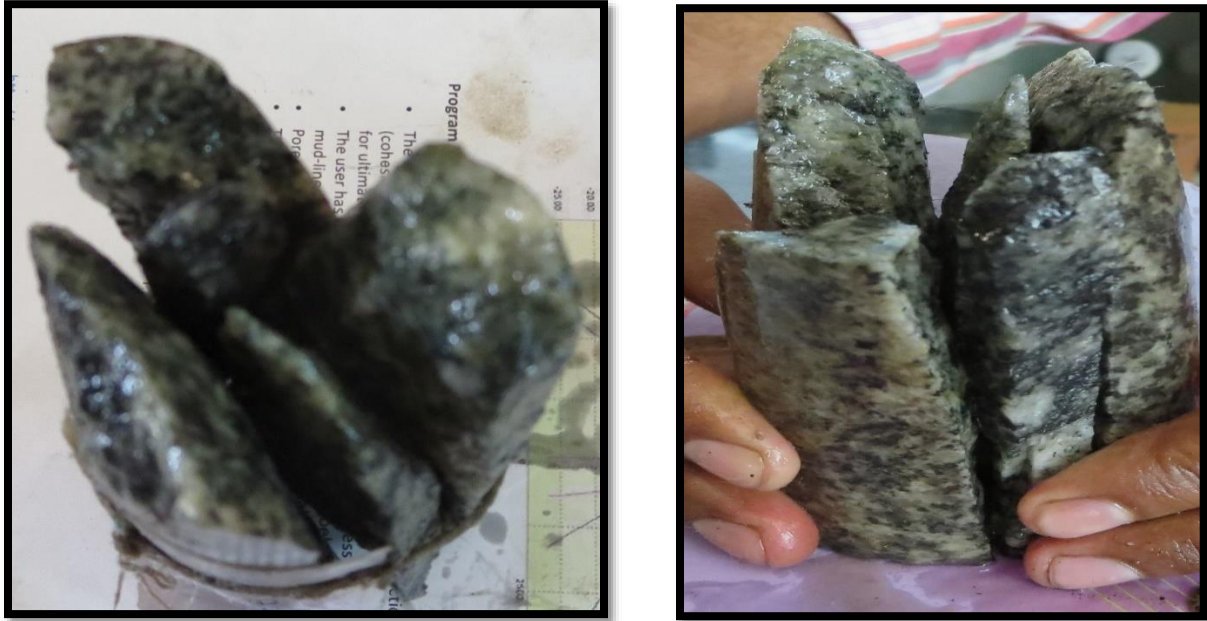
Fig.5.1.2 (b): Fracture profile (top view & side view) of Granitic Gneiss sample after Triaxial Test.

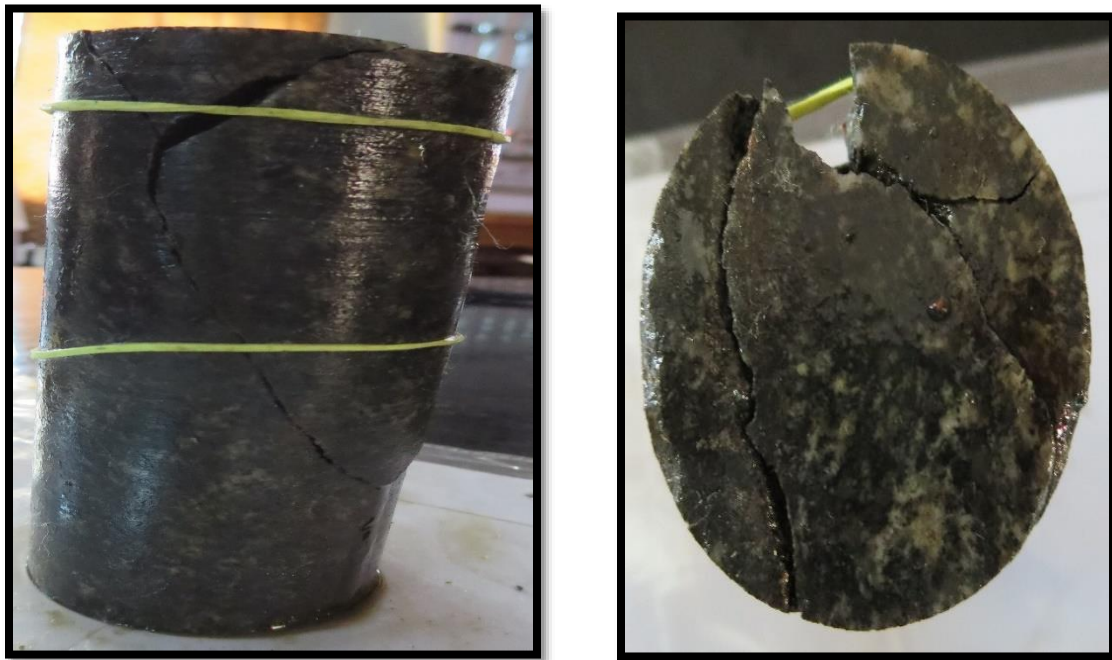
Fig.5.1.2(c): Fracture profile (side view & top view) of Quartz Mica Schist sample.
